Confidential - Property Inspection Report - Confidential

## 742 Evergreen Terrace

Date of Inspection: 6/6/2025 Time: 9:30 AM

Age of Home: 1978 (47 years) Size: 2,100 SqFt

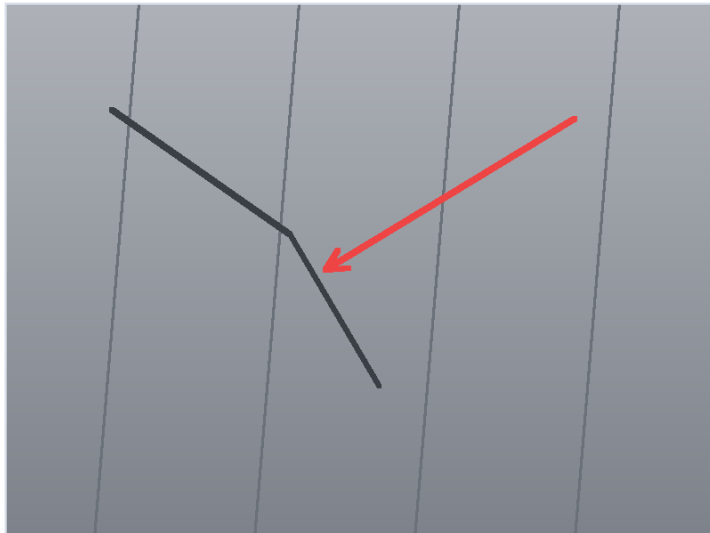
#### 2.1 **MINOR** Cracking

Settlement cracking was observed across the driveway slab. The cracking appears cosmetic at this time with no significant displacement.

*Recommendation: Recommend sealing to prevent water intrusion; monitor for movement.*

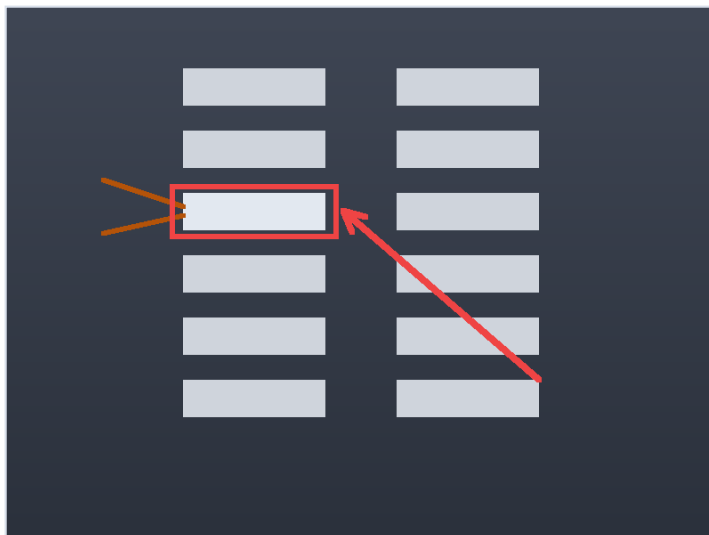
##### 3.1 **SAFETY** Electrical deficiency

A double-tapped breaker was observed in the main service panel (two conductors under a single breaker not rated for it), and the kitchen counter receptacles lacked GFCI protection.

*Recommendation: This is a potential safety concern. Recommend correction by a licensed electrician.*
